# Monitoring of Impact Damaged Bridge

Queensland Rail and  
EngAnalysis

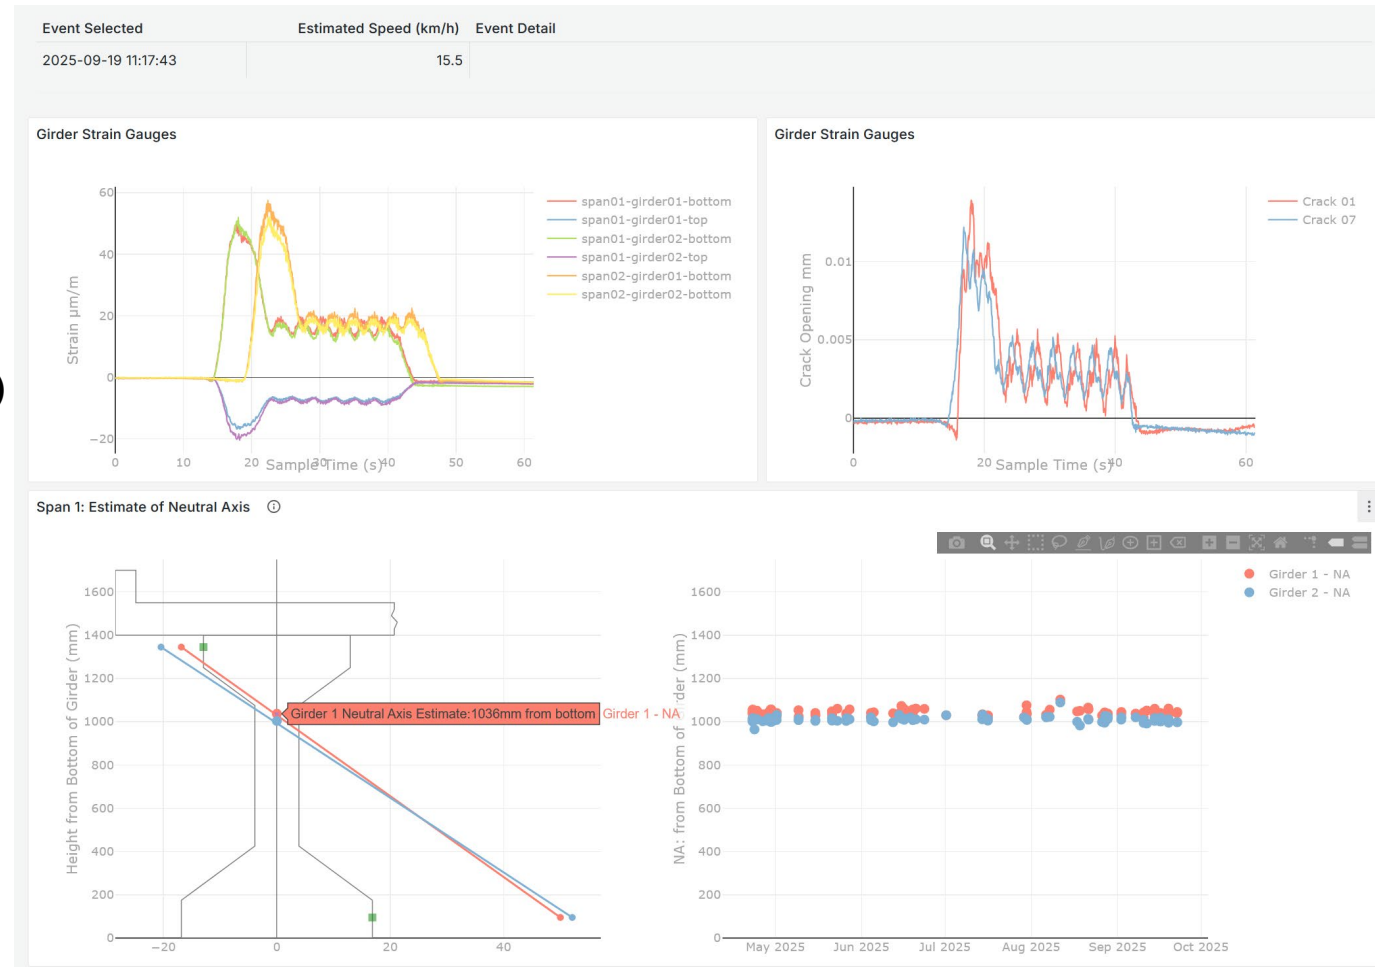
Figure – 6

- Metrics
  - Peak strains
  - Neutral axis
  - Crack opening
  - Ratios (Span 1 / Span 2, Girder 1 / Girder 2)
  - Speed
- Dashboard
- Anomaly detection – notification (Figure-6)
- Monthly Summary

Example of monitoring data triggered by traffic movement

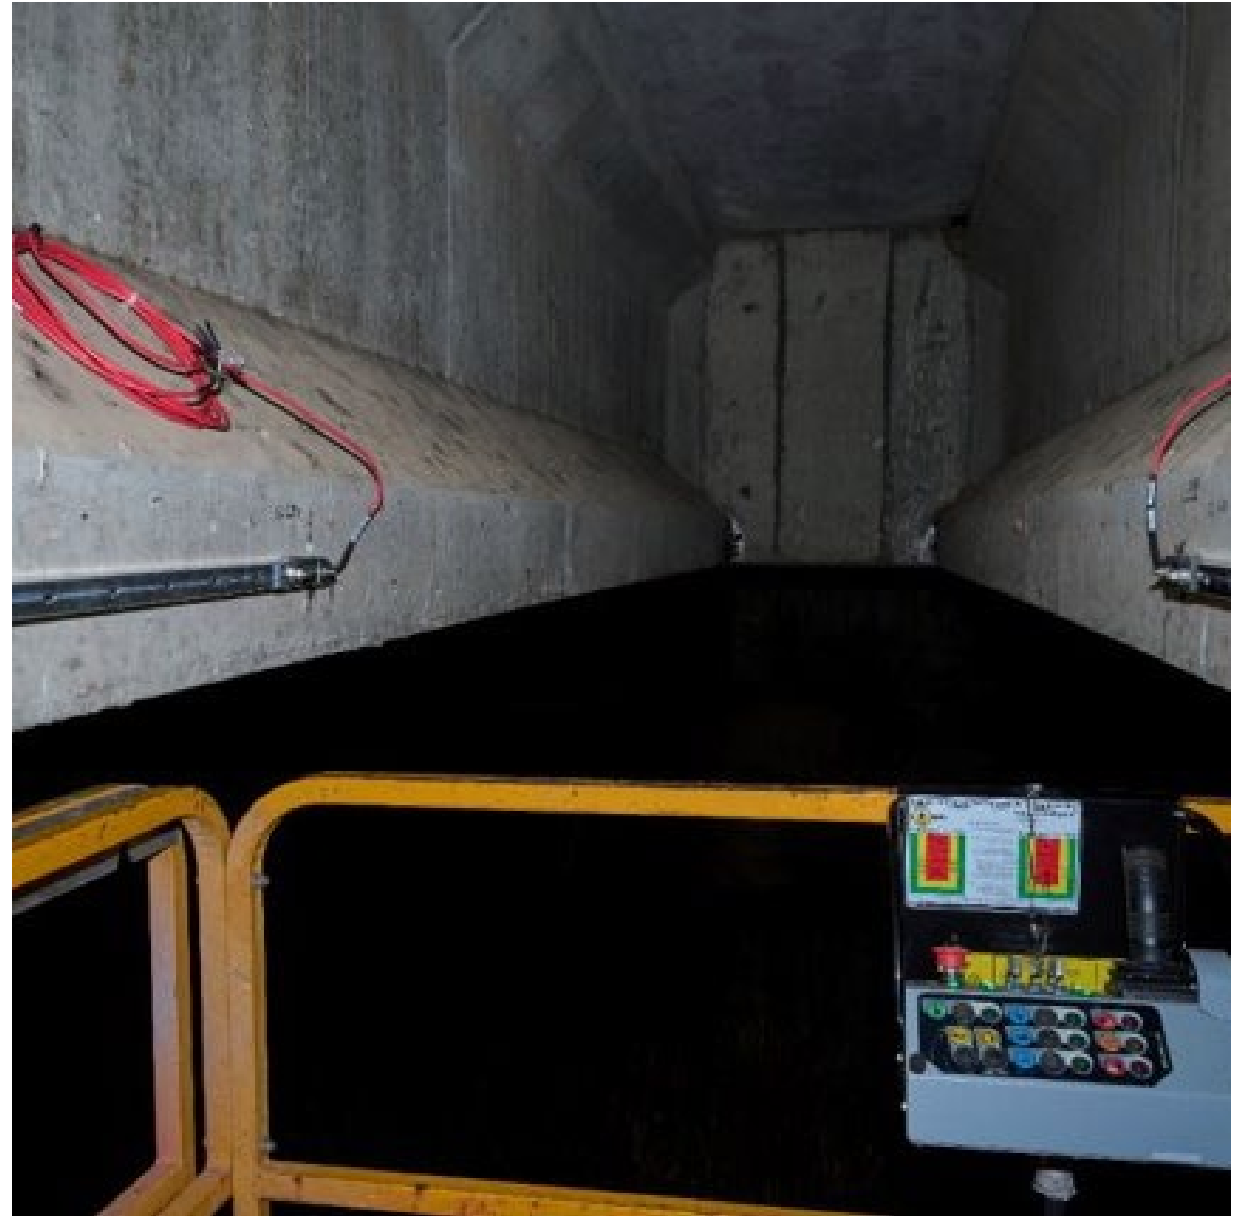
Figure - 1

Installed strain gauges (*Queensland Rail*)

- Data acquisition, remote communications, solar and battery
- Strain gauges:
  - Mid-span top and bottom of girders on span 1 and span 2
  - Crack opening - over the repaired cracks
  - Ratios
- Triggered system + long term trends

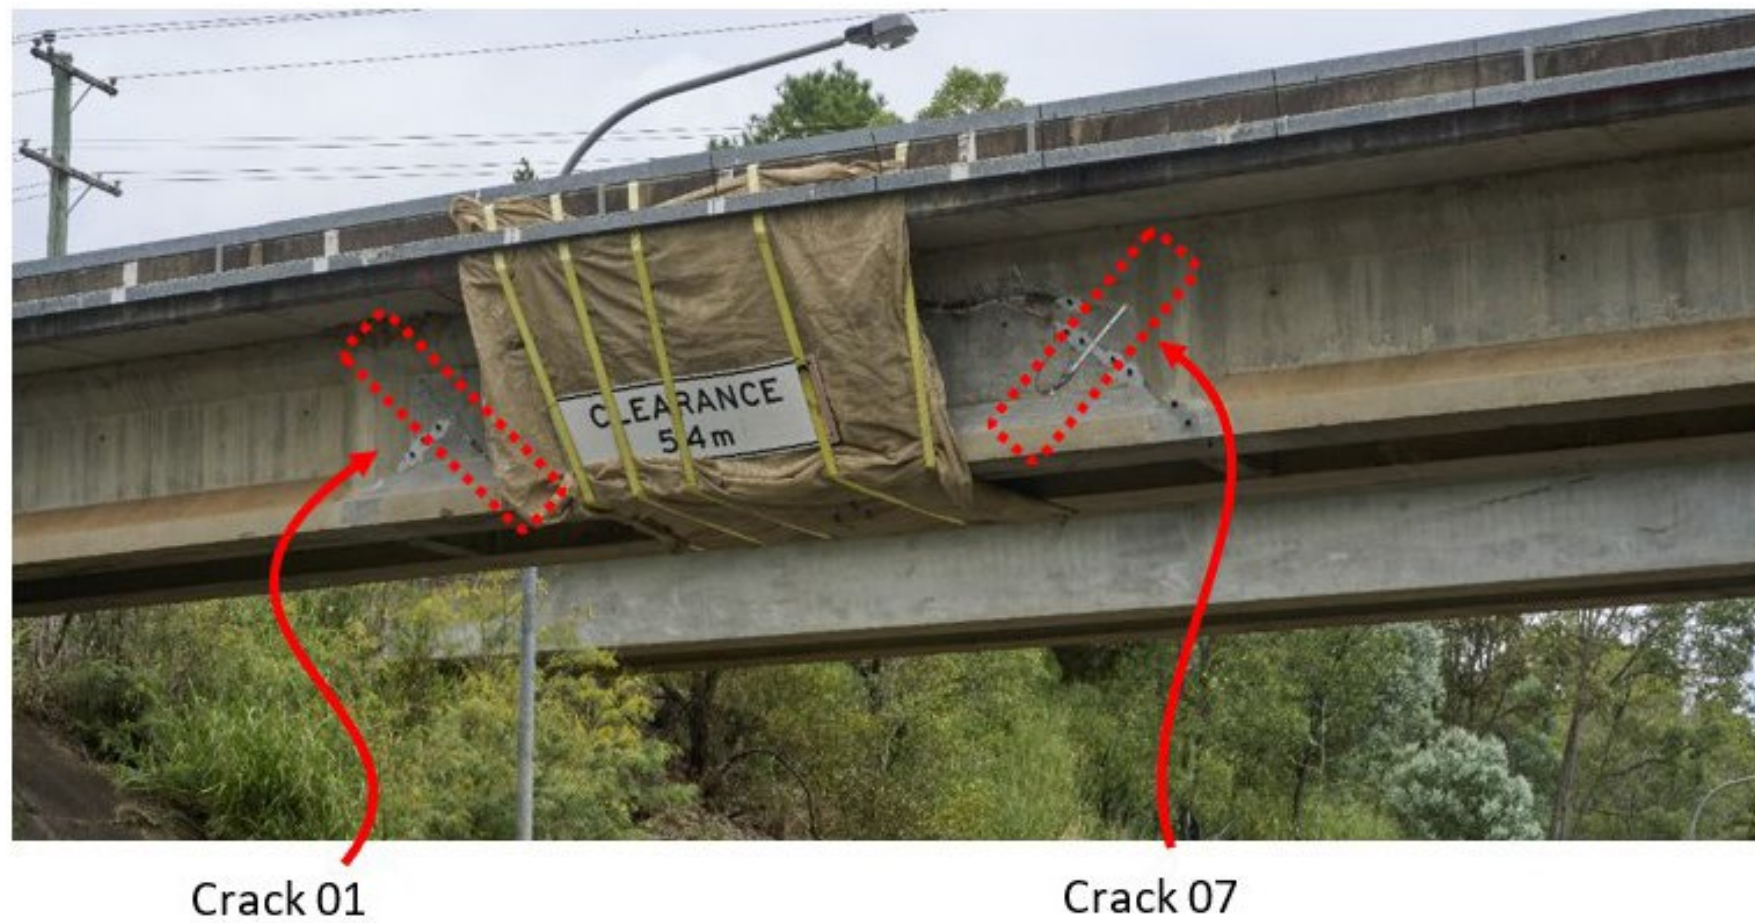
Figure – 2  
Diagonal crack locations  
(*Queensland Rail*)

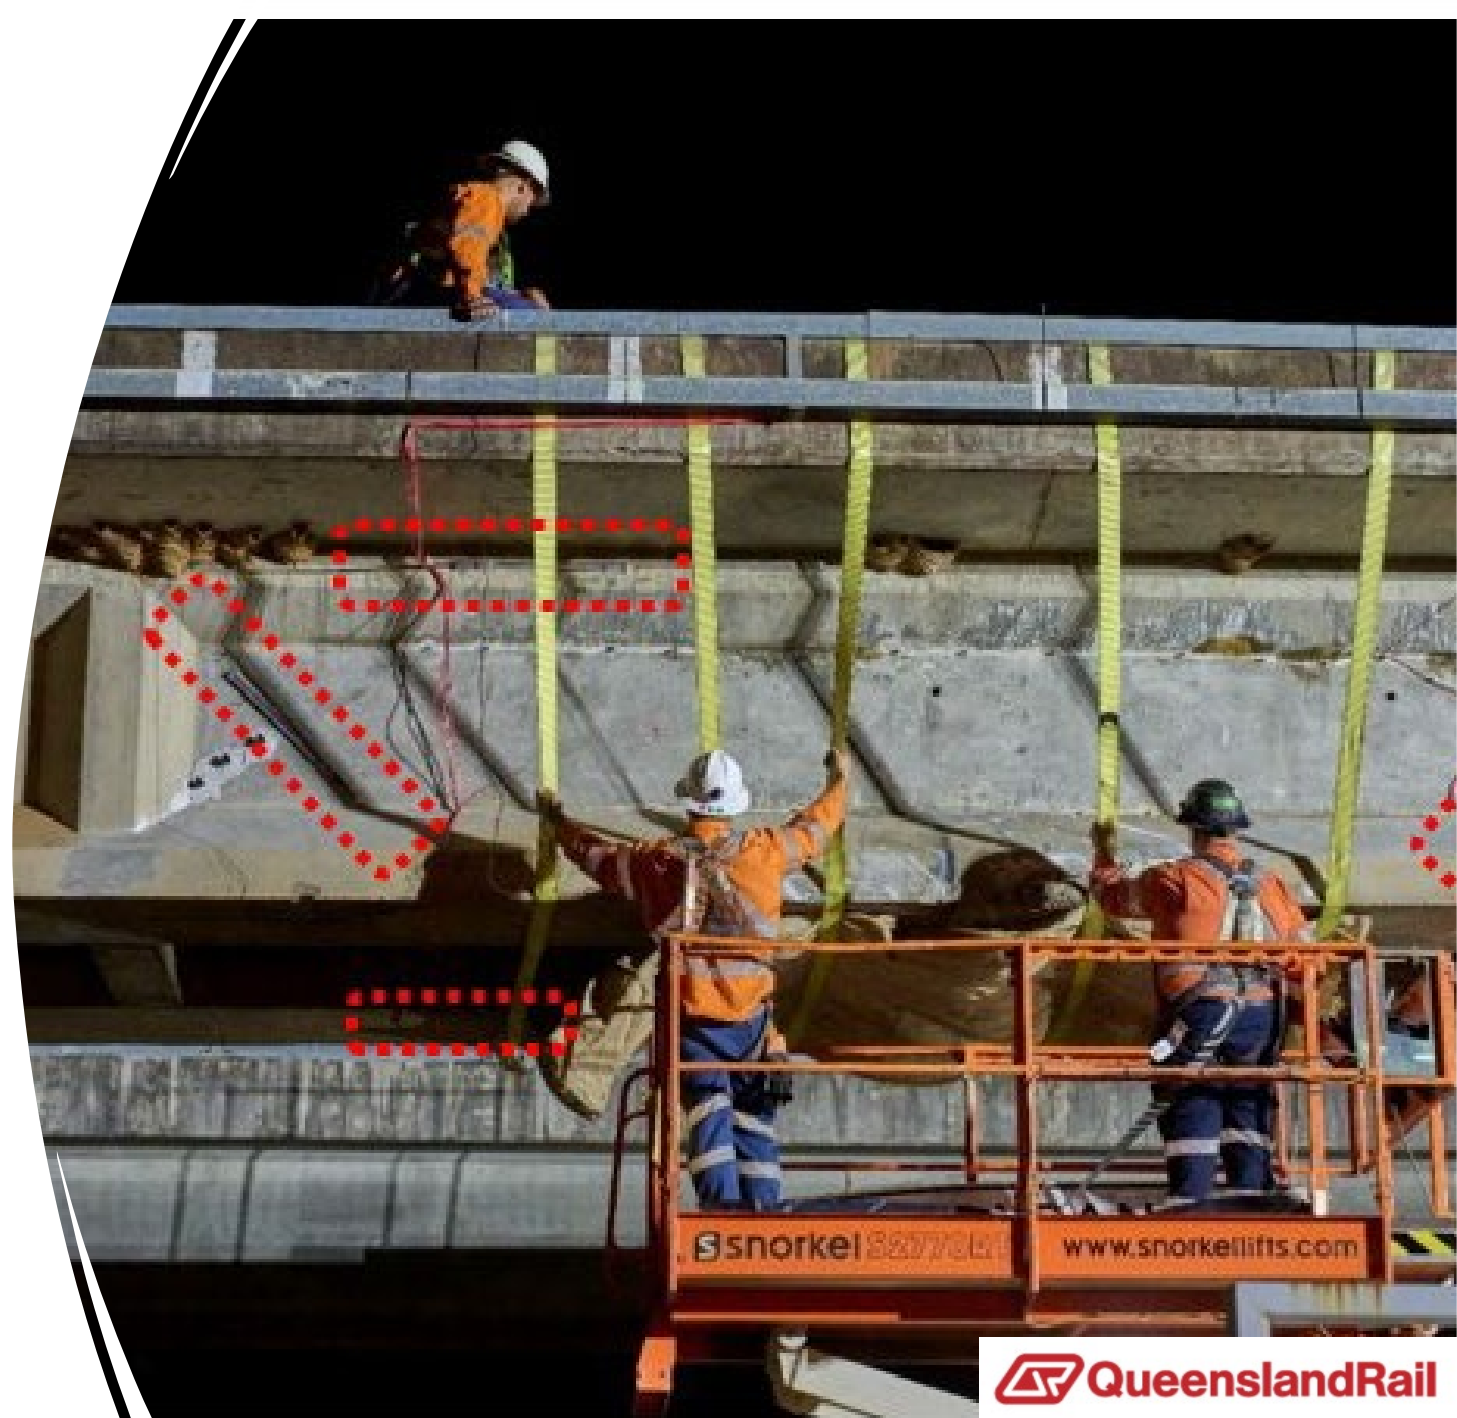
Figure - 3

Night works to secure catching  
membrane (*Queensland Rail*)

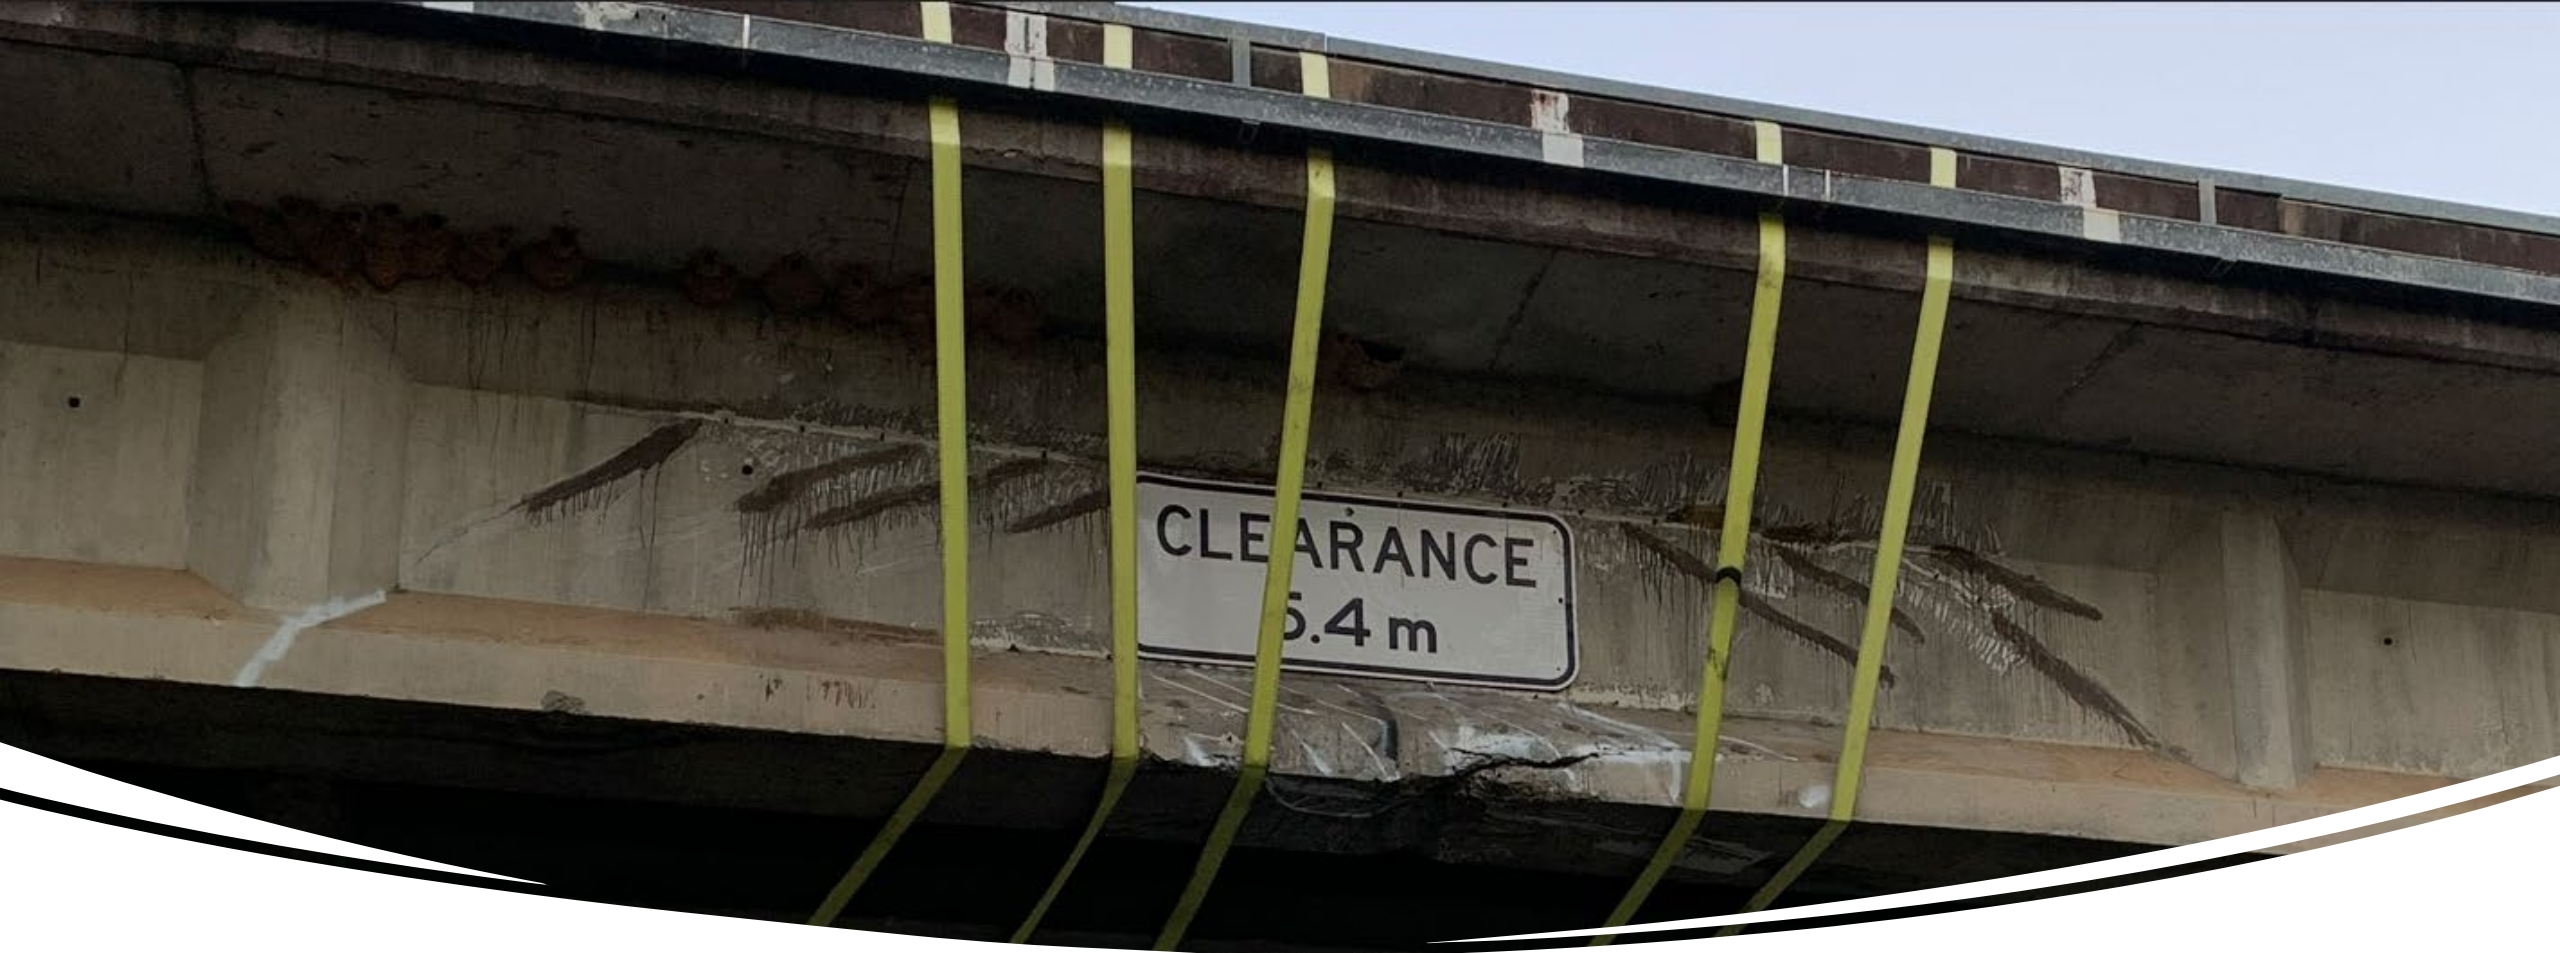
Figure - 4

Looking at the impact along the direction of travel, this one shows the shear cracks (*Queensland Rail*)
