# A Method for Estimating Resilience of Aging Masonry Veneer and Cavity Walls

Igor Chaves, M. Masia, C. Lam, L. Terry, A. Hossain, P. da Costa  
Critical Infrastructure Performance and Reliability Group

Research Advances Paper ID: 2

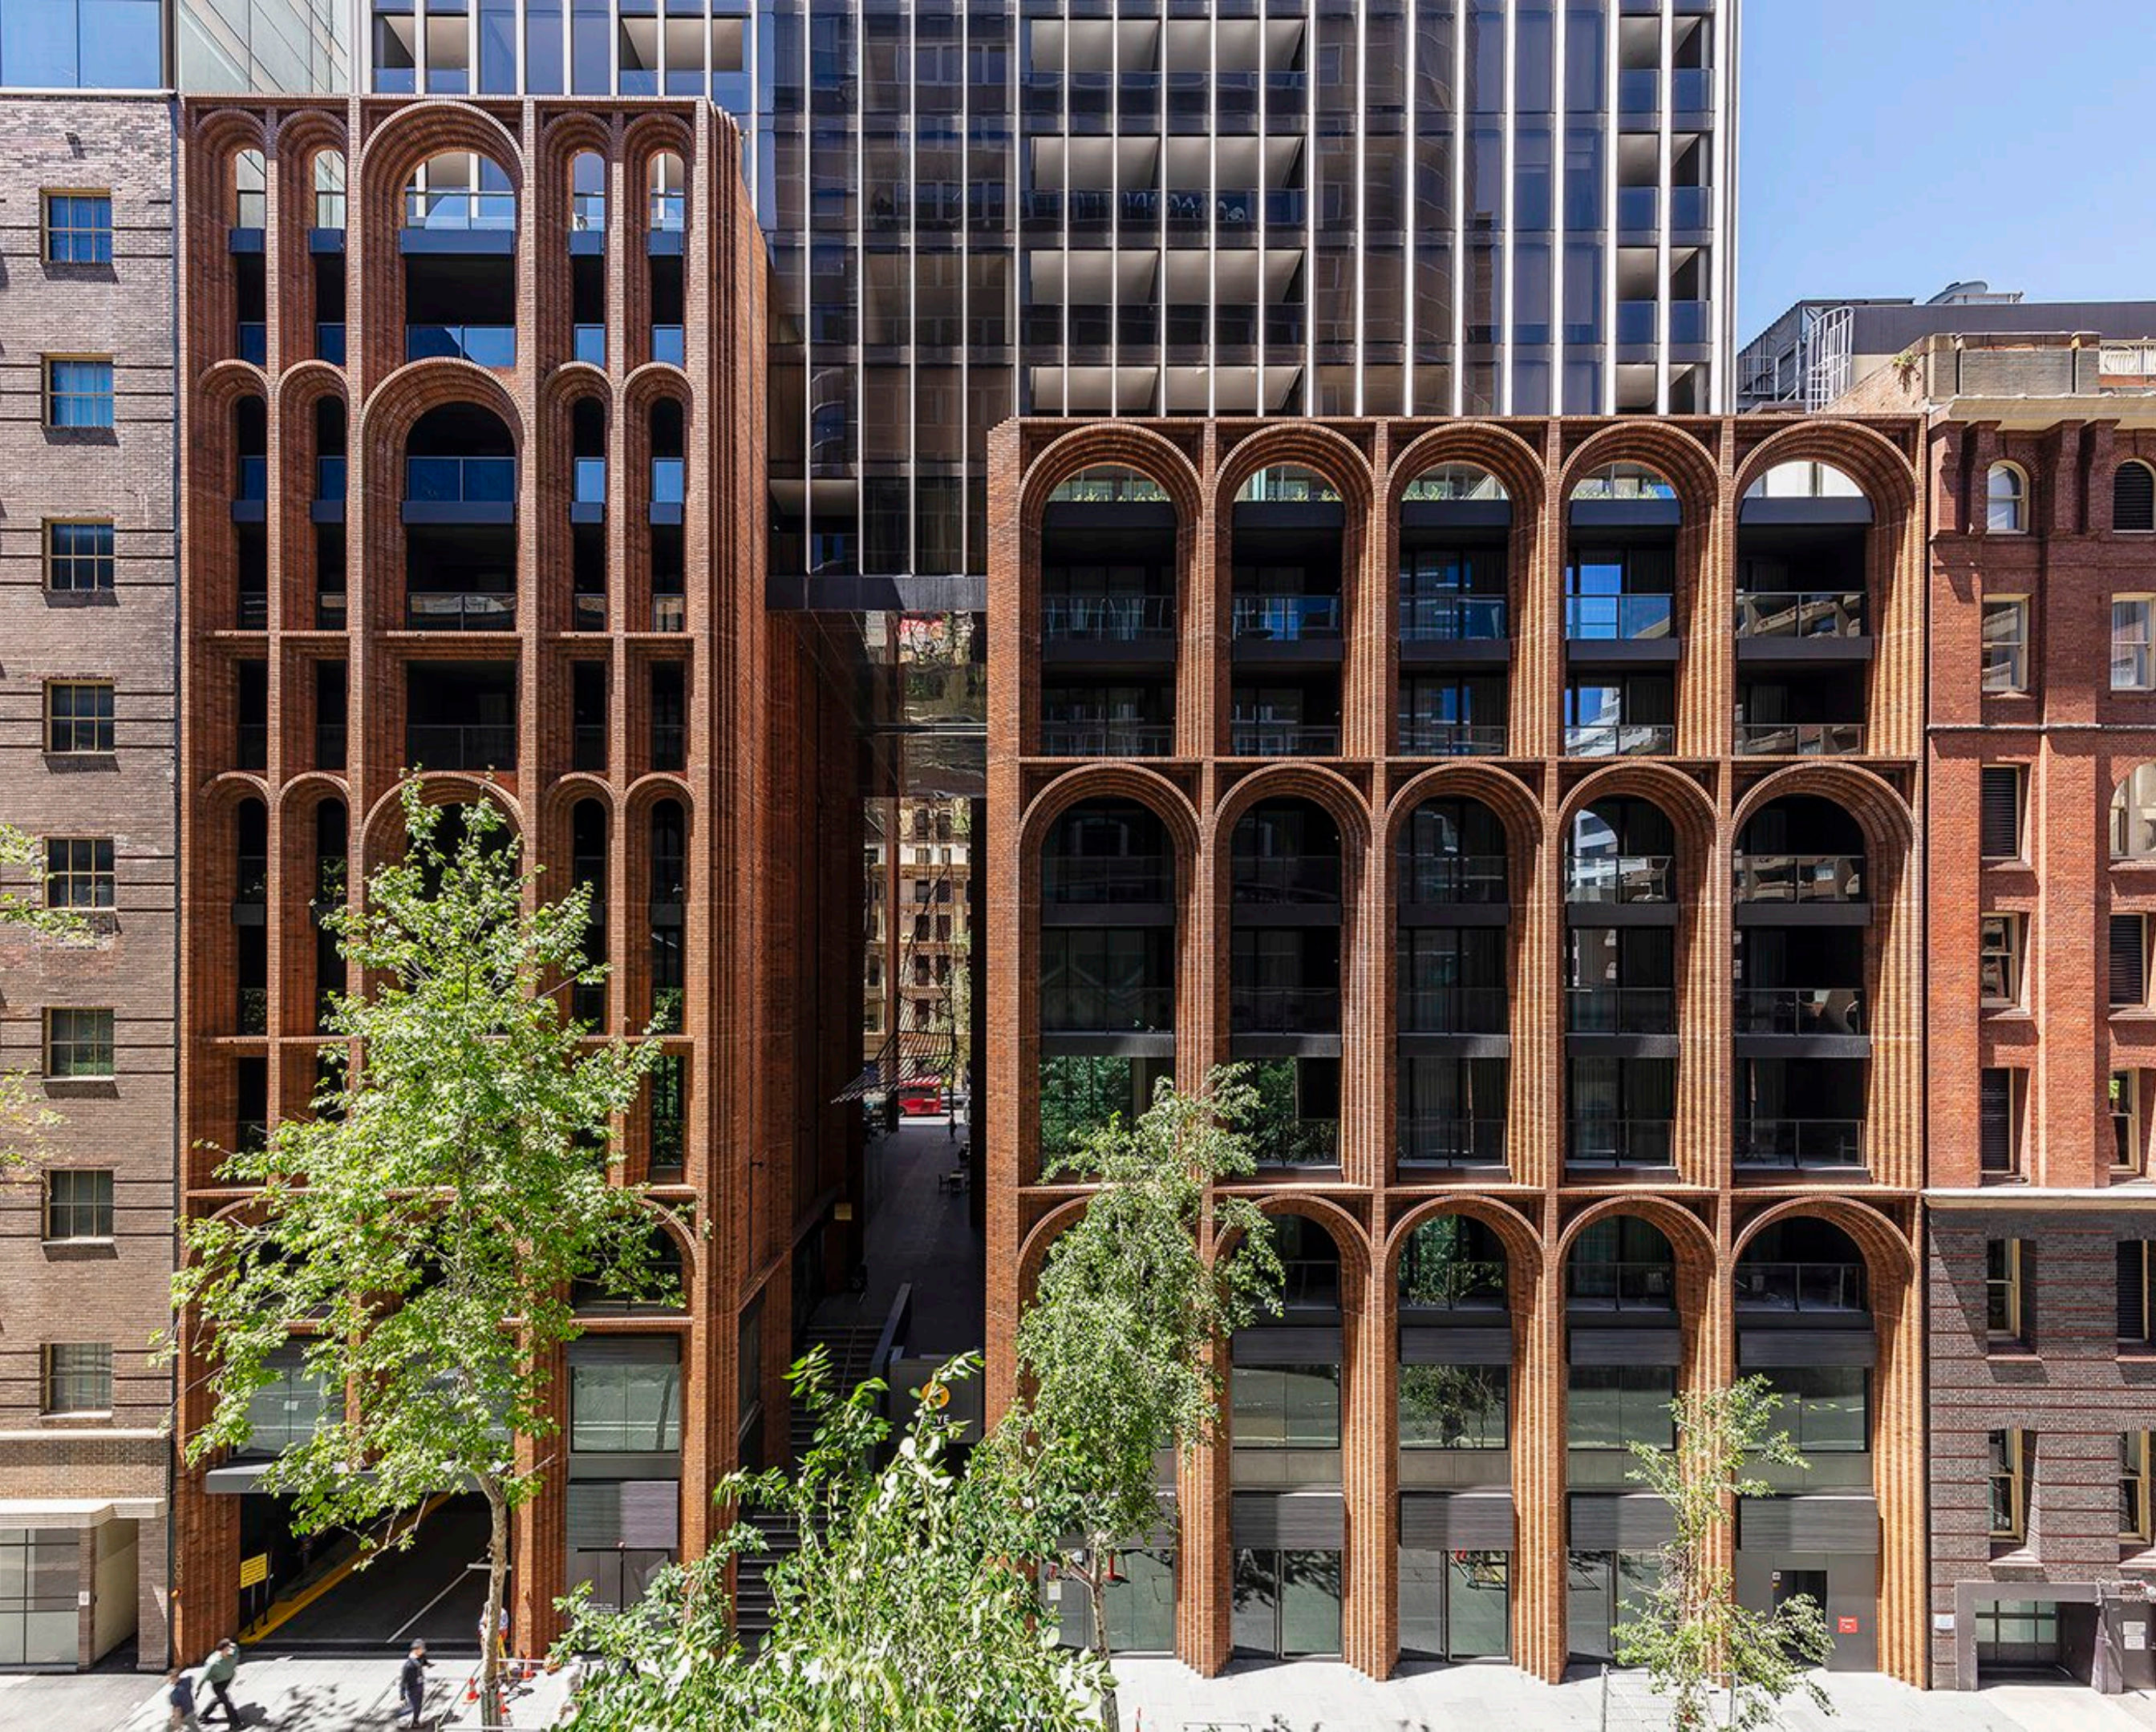
Steel lintel support masonry units

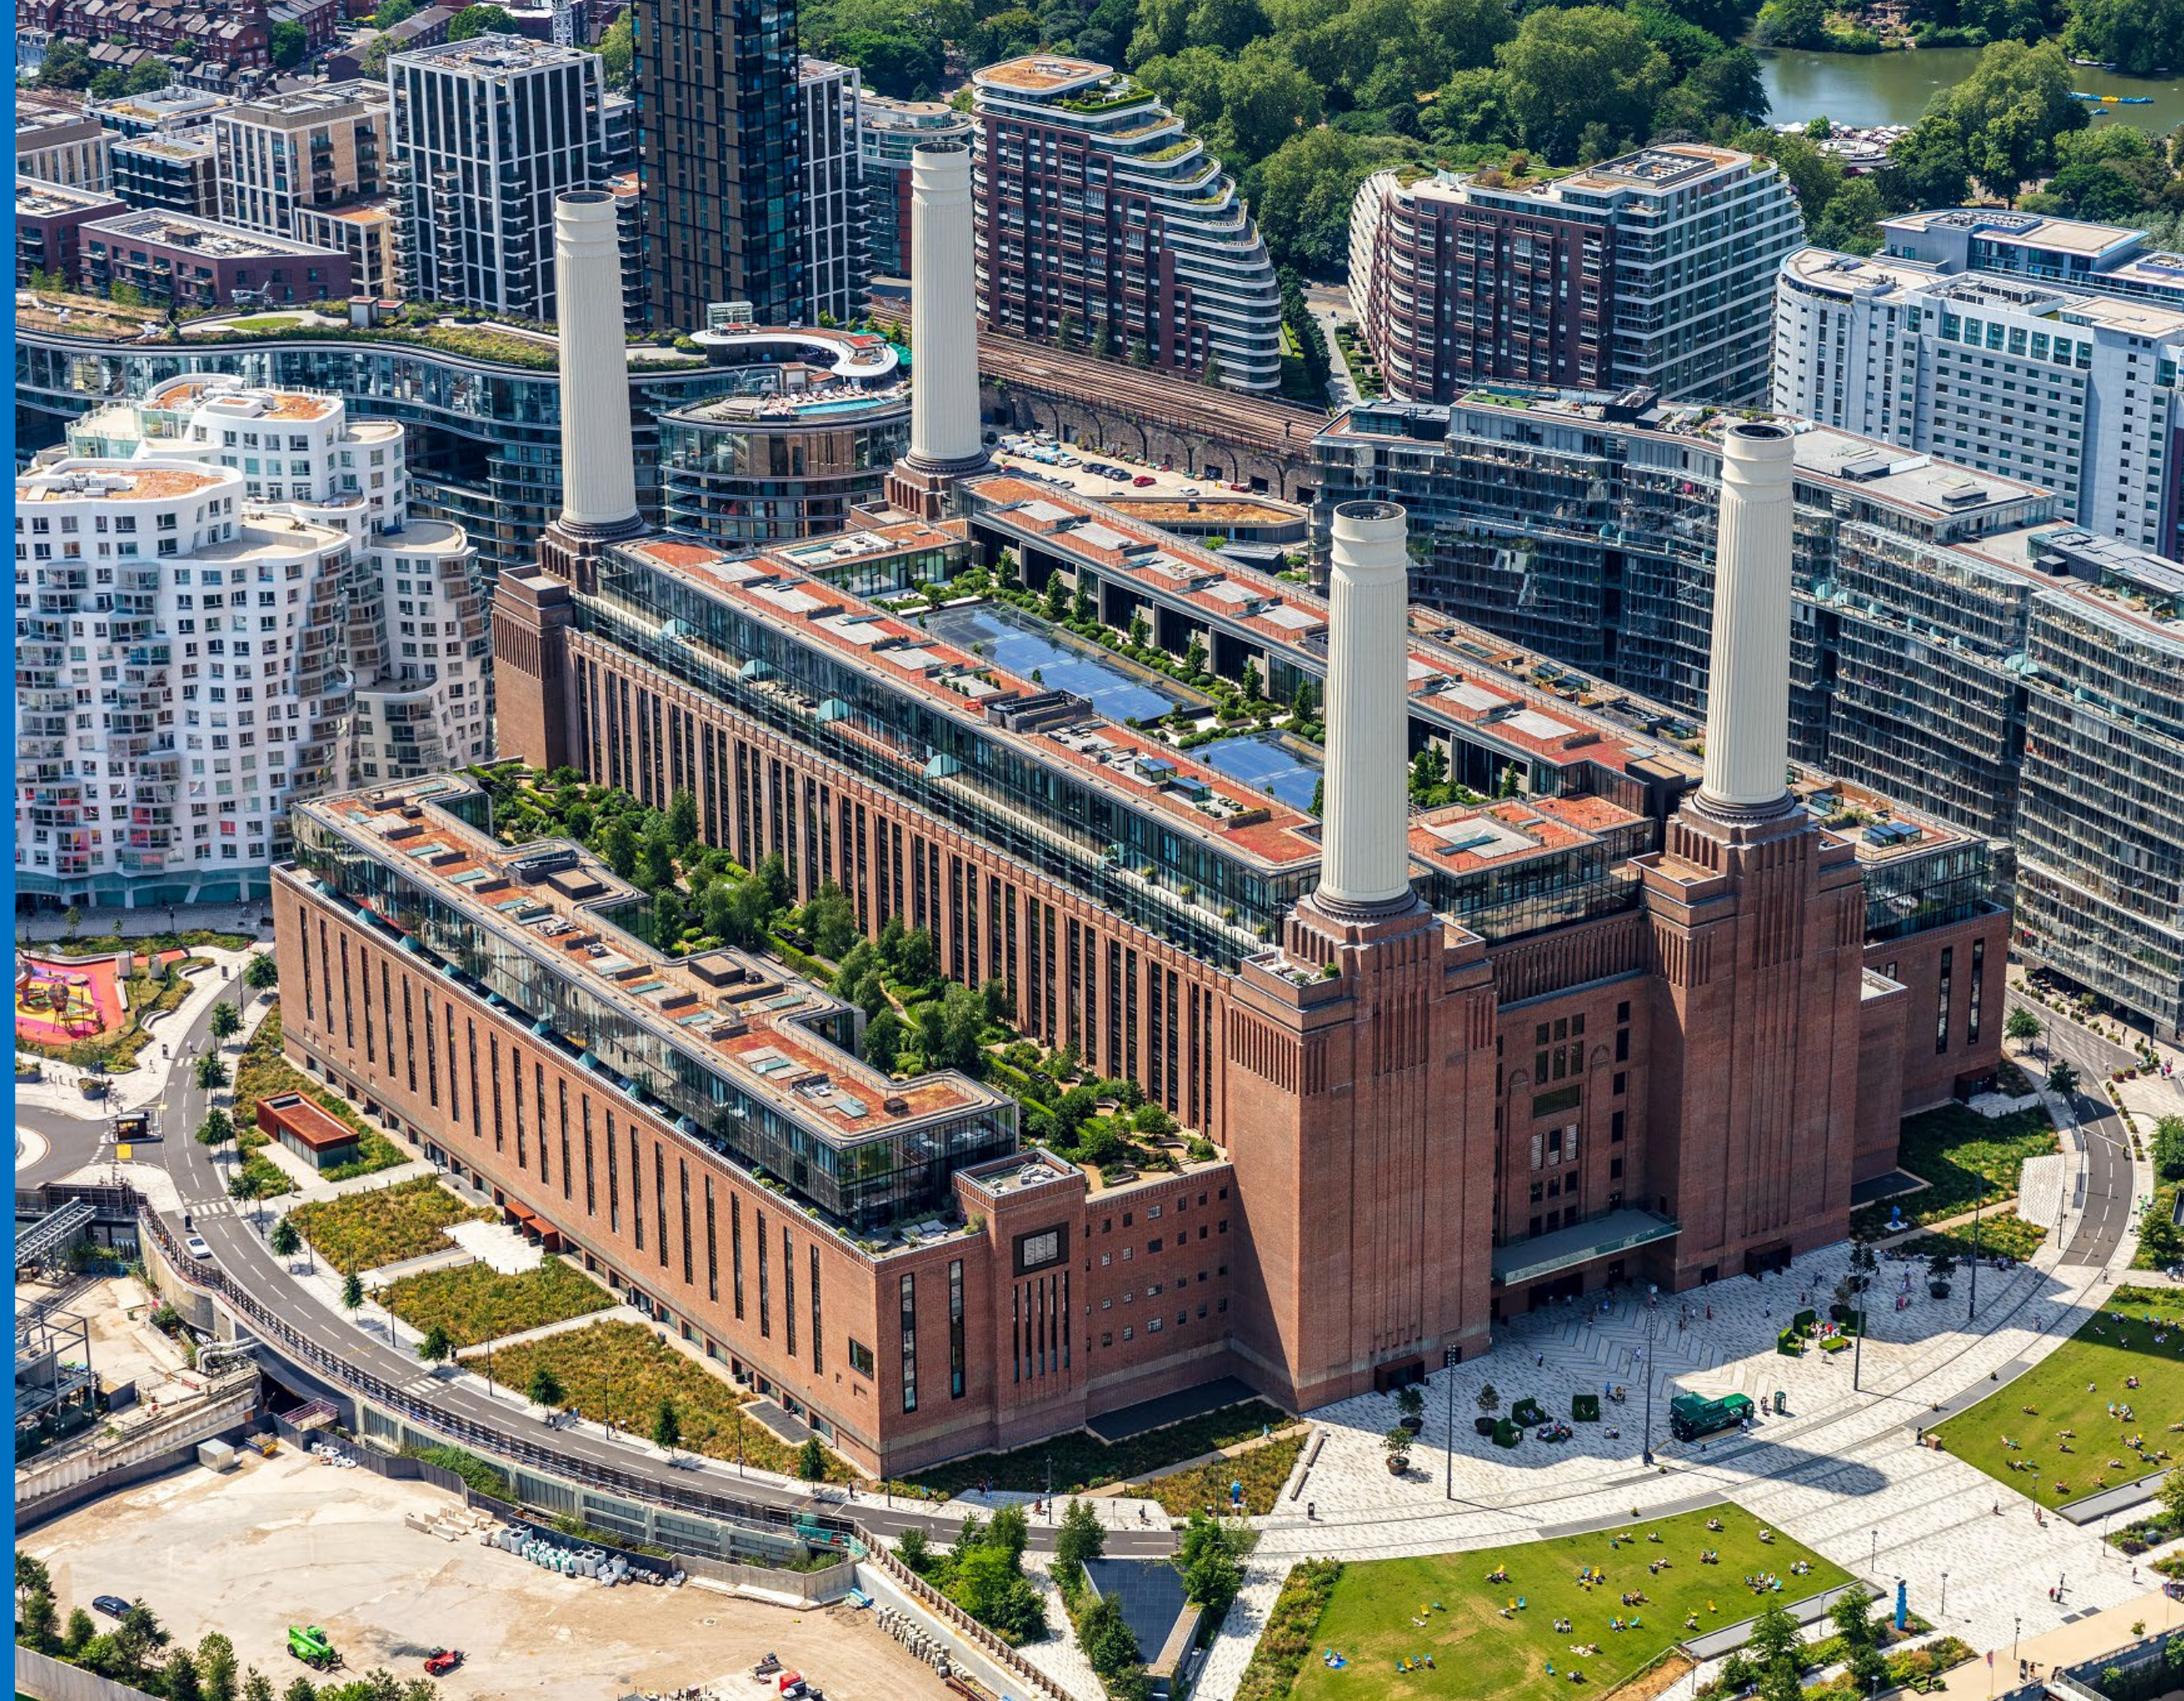
(2017) Brisbane Times, Coorparoo QLD  
12-year-old, 8m tall wall collapse  
during Villanova College School holidays.

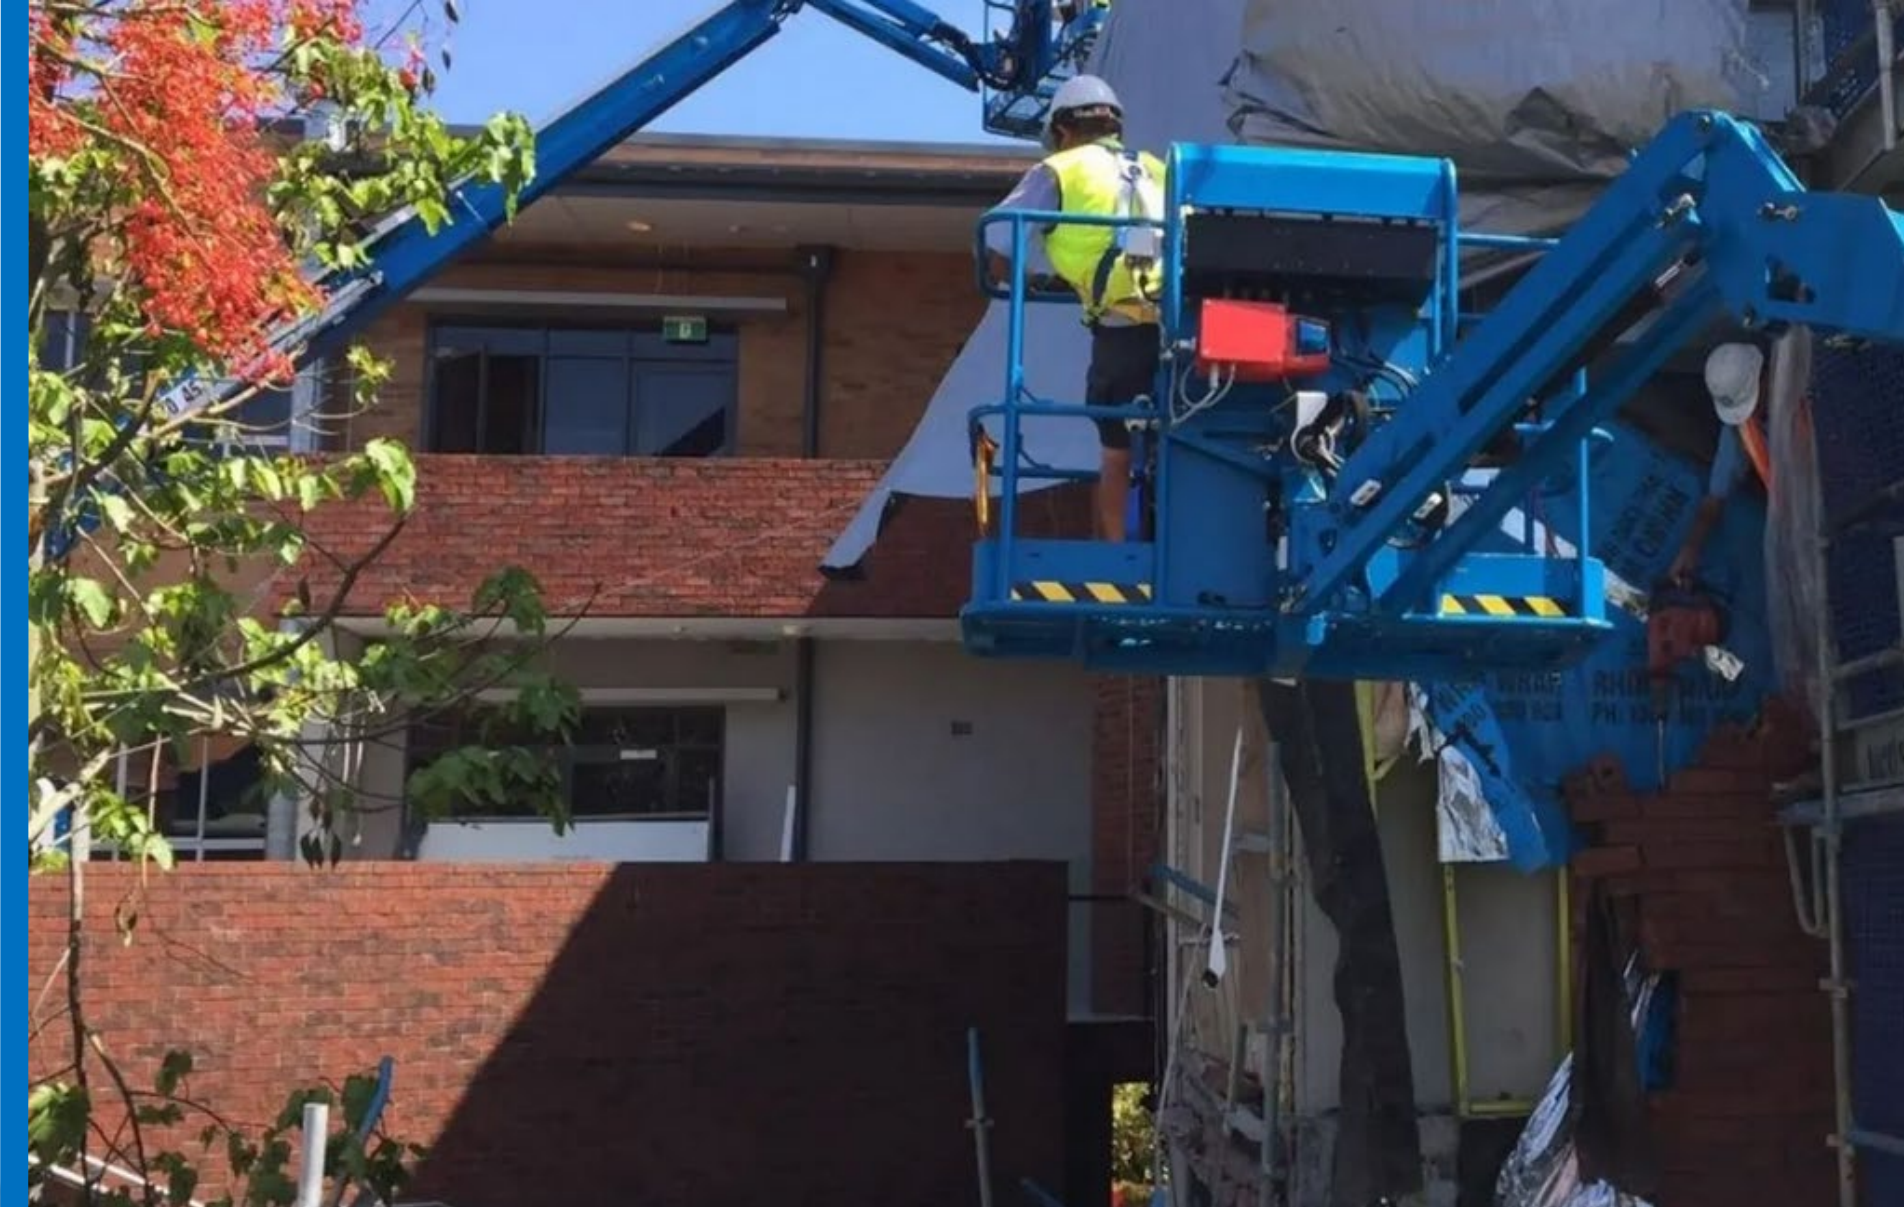
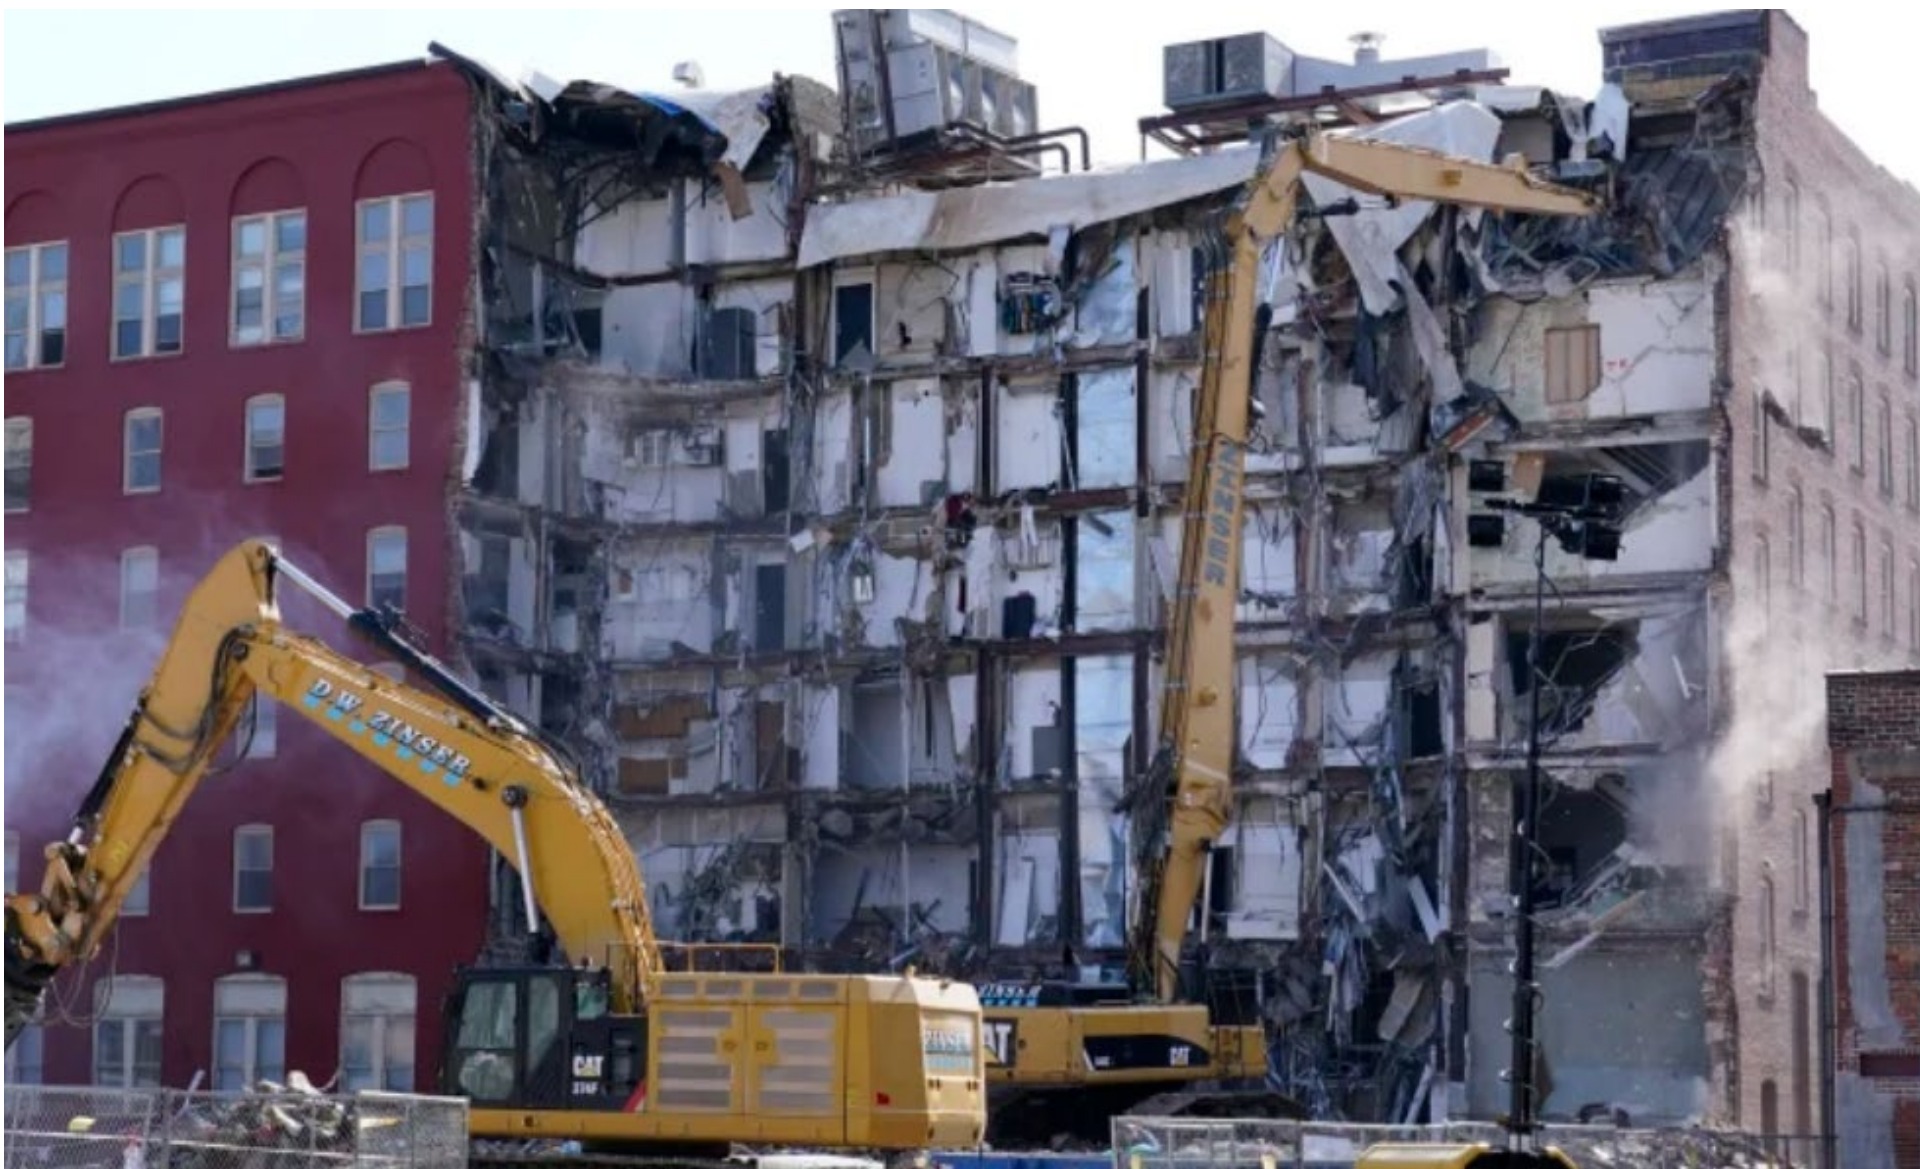
(2023) NBC News, Davenport, Iowa  
3 killed in  
116-year-old, 6-storey  
west wall collapse.

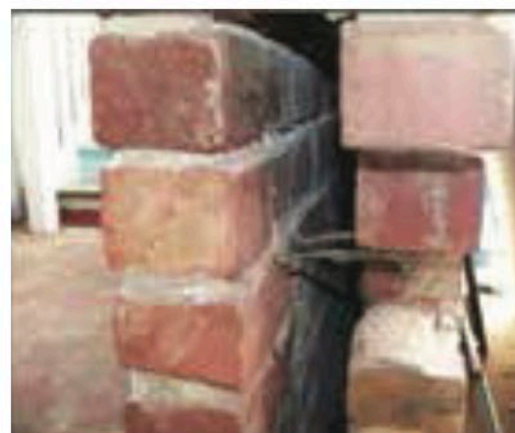
*(a) Cast iron (left 2) and wrought iron (right 2) ties (reproduced from Hamilton, 1958)*

*(b) Typical cavity wall cross-section showing metal ties*

Typical metal ties and typical cavity wall cross-section

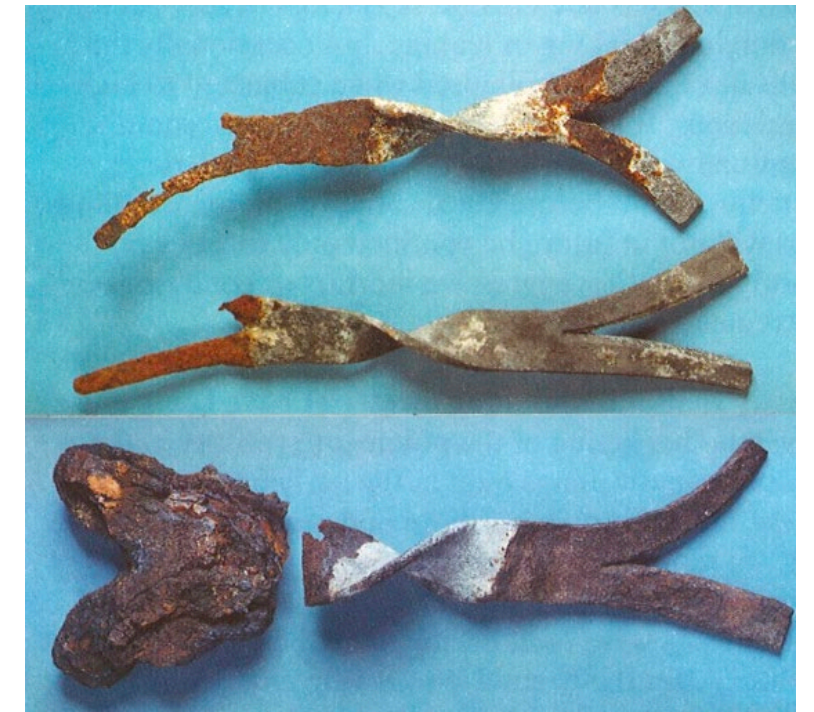
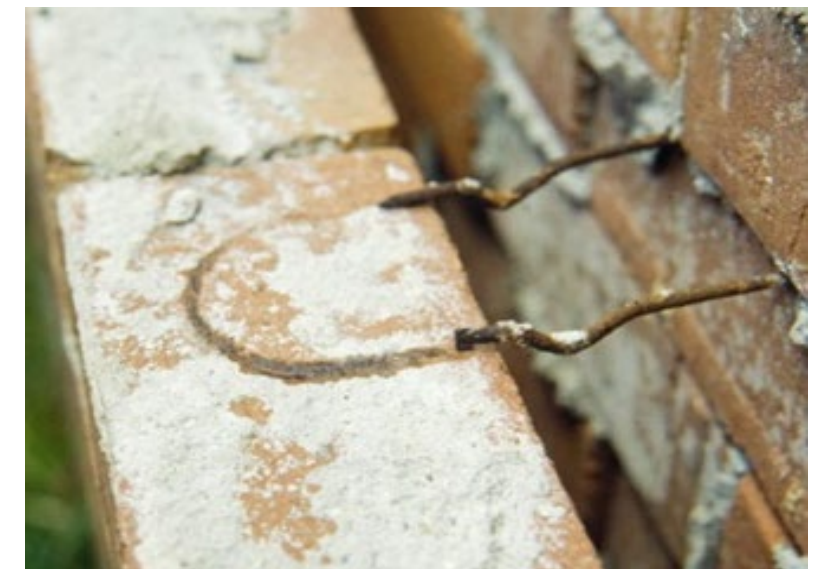
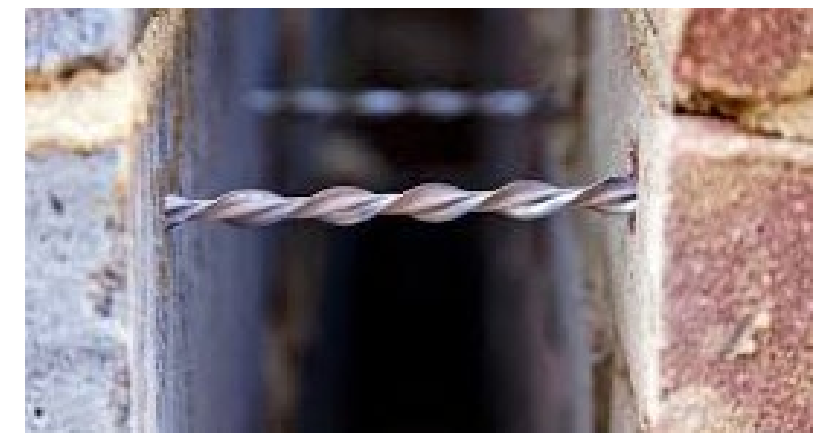
(2015) Dizhur, D., Ingham, J., et.al  
Struct. Eng. Soc. Of NZ Journal, Vol 28 (1) 13 pages.  
Historical Study of URM Earthquake Performance

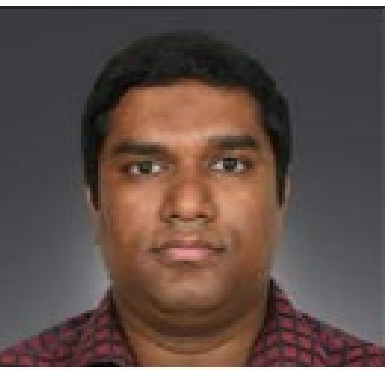
Hossain, M.A., et.al (2025) Assessment of a 60-year-old building near lakeside, NSW, C&P2025, paper 11.

Hossain, M.A., et.al (2024) Evolution of corrosion considerations in the AS3700 masonry standards, C&P2024, paper 24.

(1963) 1<sup>st</sup> Block-Masonry Stand. → (1977) Corrosion resistant metal ties → (1988) Exposure Classes, SS304

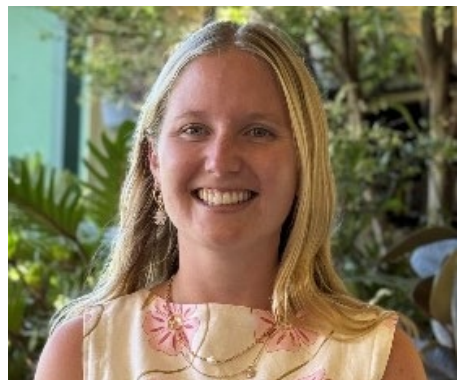
Terry, L., et.al (2025) Investigation of galvanized coating weight and thickness, C&P2025, paper 15.

Terry, L., et.al (2025) The impact of corrosion on strength of wall ties, Australian Journal of Structural Engineering.

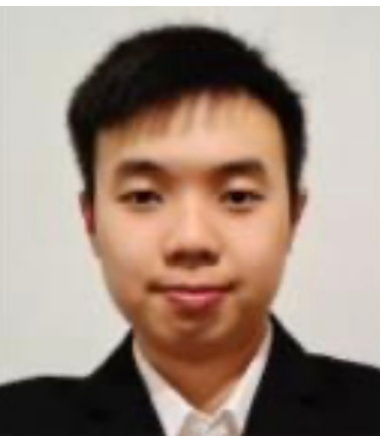
# Vibration-Based Method

Lam, C.Y., et.al (2025) Identification of wall tie deterioration using FEA updating model, 15<sup>th</sup> CMS, paper 72.  
Lam, C.Y., et.al (2025) Assessing wall tie deterioration through vibration-based methods, buildings 15:1226

1. Obtain Frequency Responses
  2. Re-Capture and note decrease in frequency responses
  3. Compute the absolute mode shape differences  
(5<sup>th</sup> order Butterworth low-pass filter – 350 Hz cutoff, only first few modes are of interest for masonry)
- \* Trialing use of non-contact measurement systems

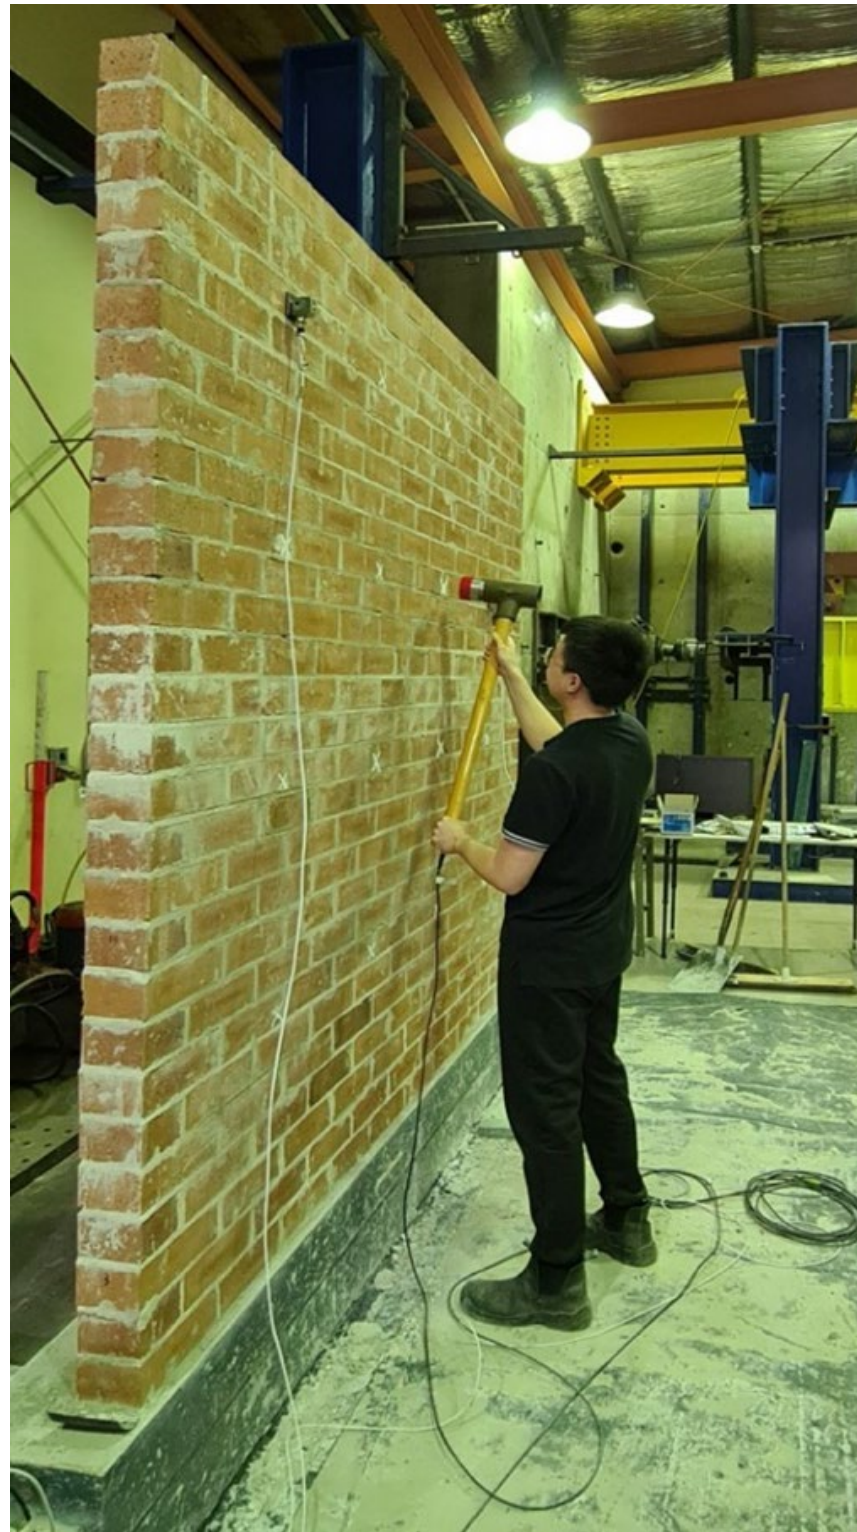
# Vibration-Based Method

Lam, C.Y., et.al (2025) Identification of wall tie deterioration using FEA updating model, 15<sup>th</sup> CMS, paper 72.  
Lam, C.Y., et.al (2025) Assessing wall tie deterioration through vibration-based methods, buildings 15:1226
