Rockfield

Creating Value from SMH in
the Australian Context

OVER 20 YEARS OF ENGINEERING EXCELLENCE

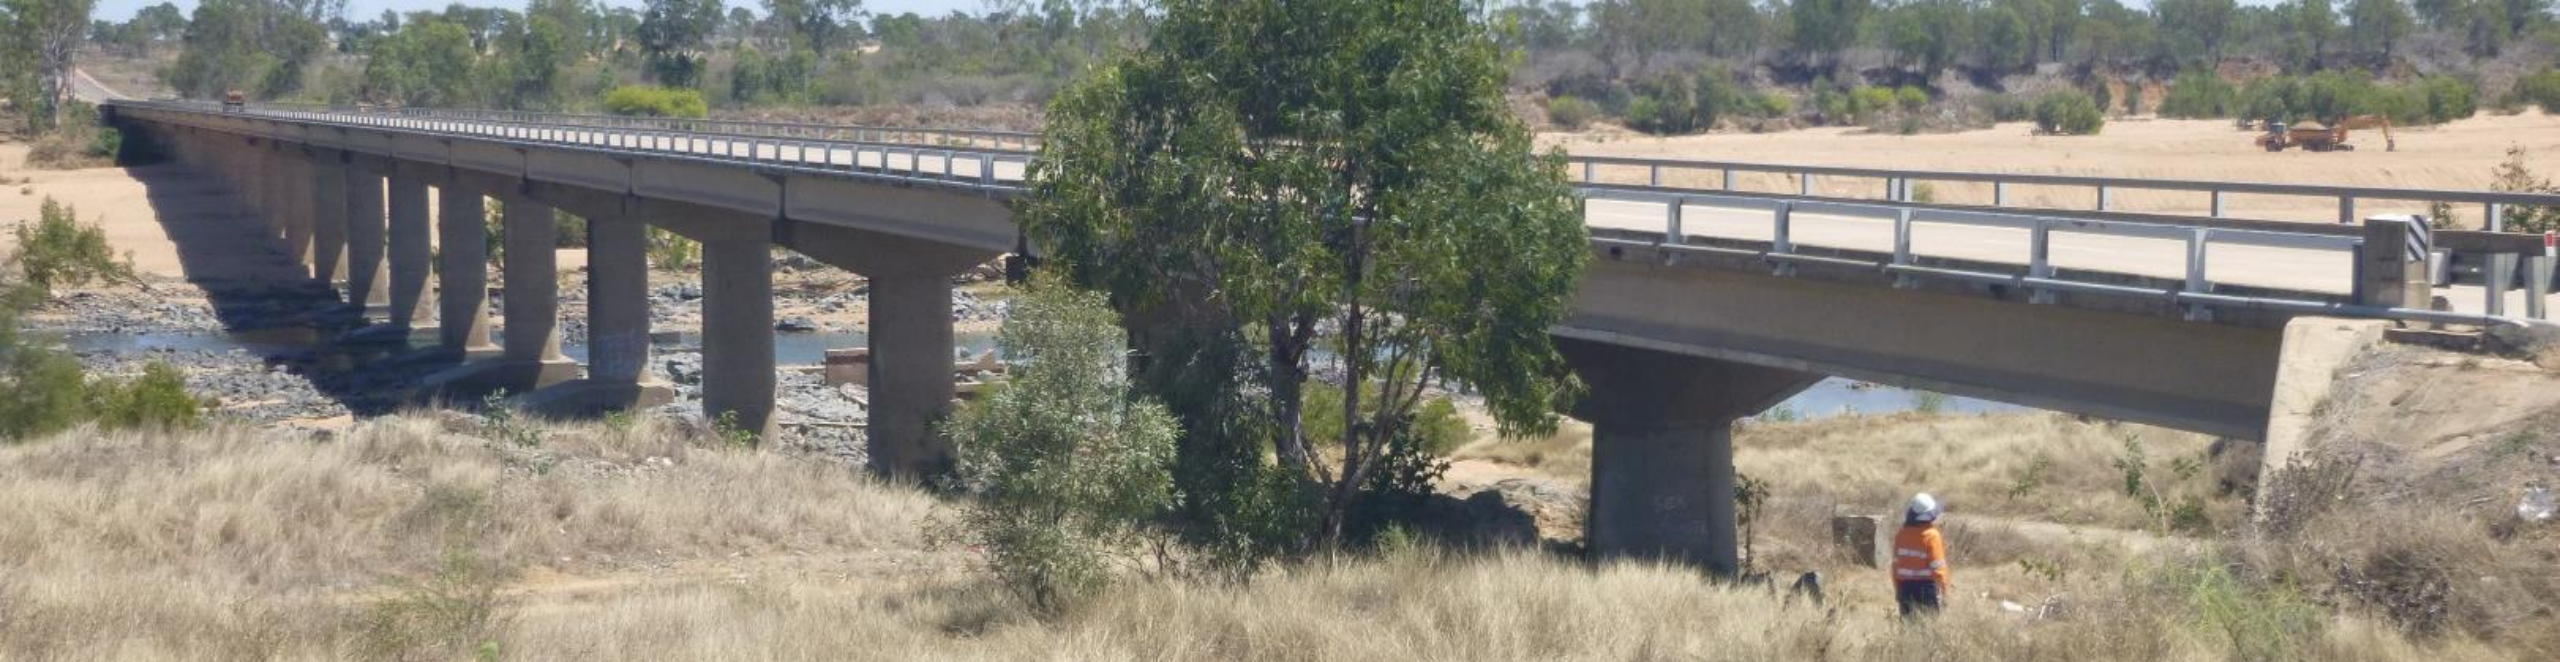
Due to its age and unique design, the Department of Transport and Main Roads (TMR) has been closely monitoring the condition of the bridge for many years. Investigations initiated in 2015 led to the discovery of fatigue cracks in several steel elements of the bridge and in February 2019, TMR imposed a 50.5 tonne load limit to manage heavy vehicle impacts. In November 2020, TMR imposed changed traffic conditions to manage the risk of fatigue and brittle fracture.

The bridge has been operating as a single lane structure with a reduced speed limit and traffic management in place and loads have continued to be limited to 50.5 tonne. During this period, the bridge has been inspected at all critical locations with short-term repairs completed. Cameras and sensors have been installed to measure the performance of the bridge and the control measures.

To date, the cameras and sensors have recorded traffic for six months. Load tests were undertaken to calibrate the sensors monitoring vehicle compliance and the effectiveness of the single-lane operation of the bridge. The data has also been used to verify modelling for the rate of fatigue damage and combined with the NDT results to update the expected fatigue and brittle fracture behaviour of the bridge.

The updated modelling indicates that the rate of fatigue damage is less than predicted. This reduces the risk of a fatigue and brittle fracture occurring to safe levels. Moving the pedestrian access from the northern to the southern side of the bridge and the inclusion of a 60 km/h speed limit further reduce any risks.

As a result, it is safe to reopen the bridge to two lanes with a limit of 50.5 tonnes.

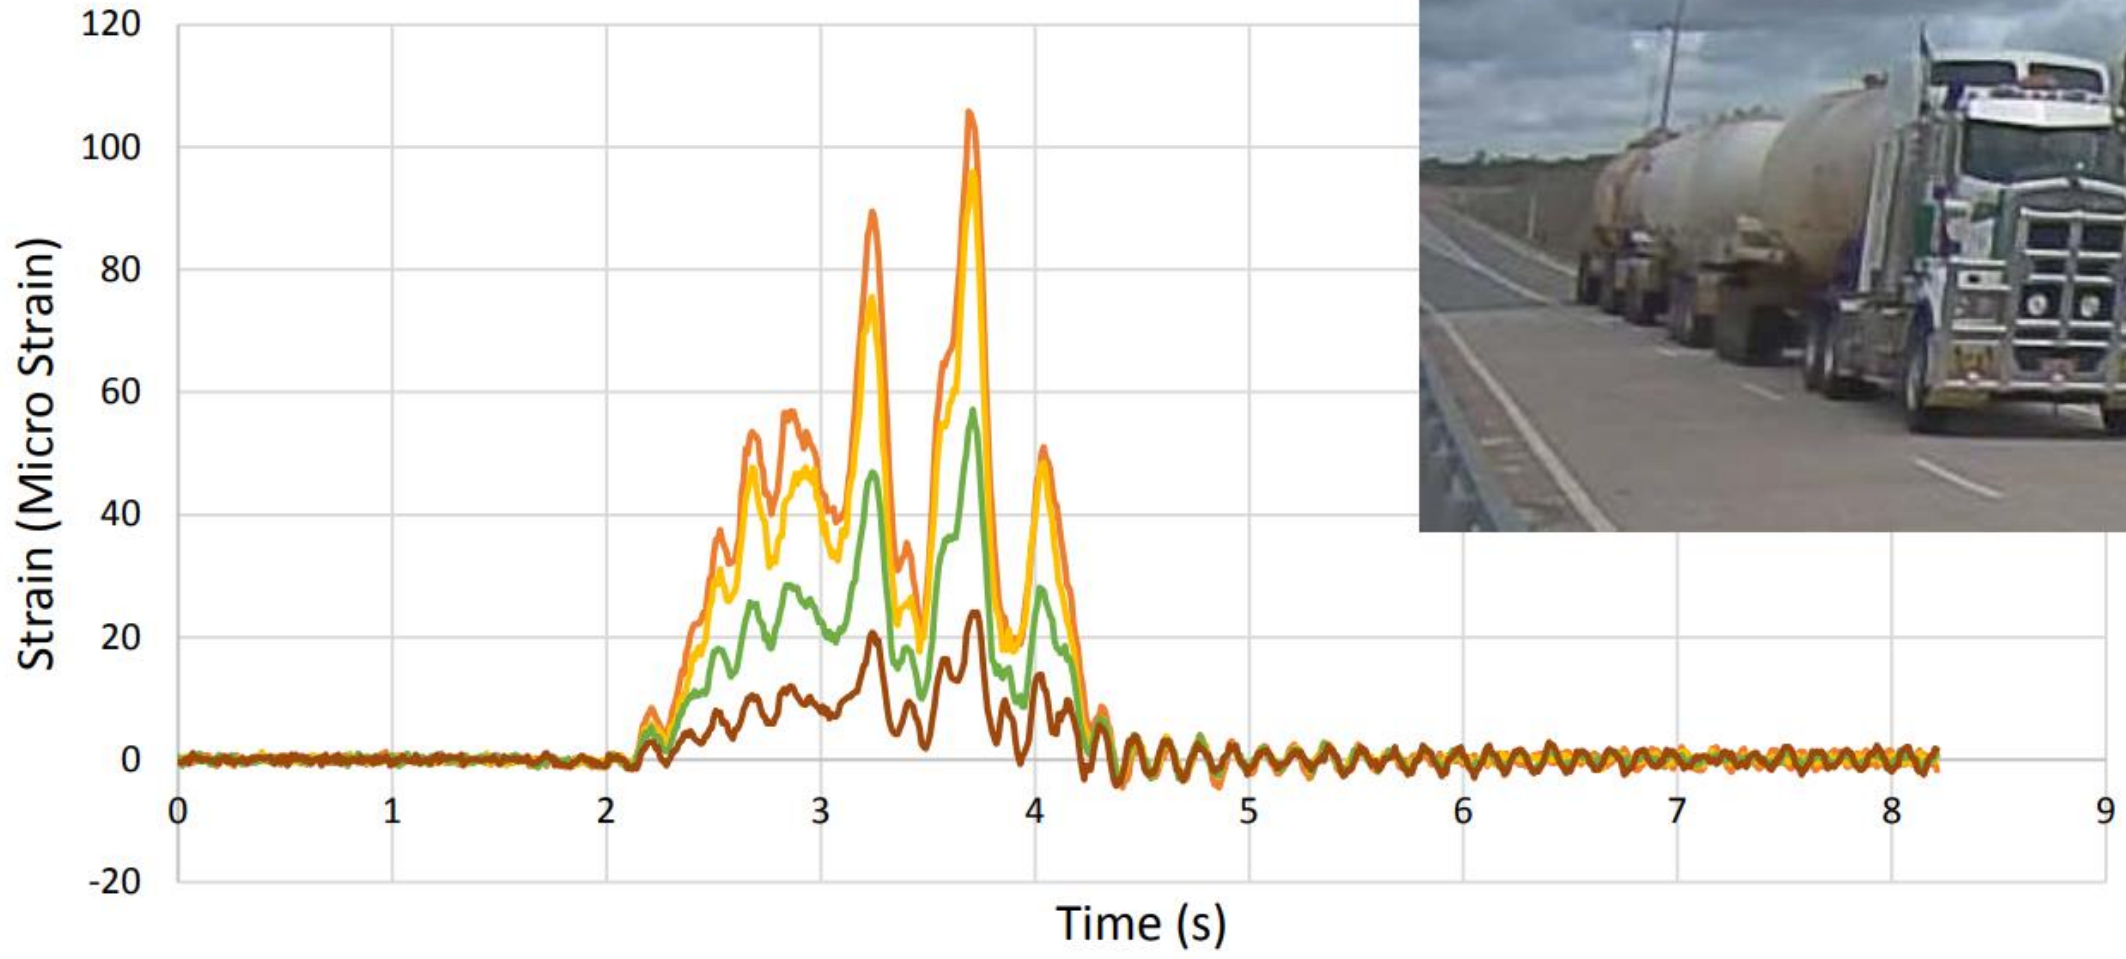
- Event A – Road Train

— "MS_CSG_1" ("micro strain") — "MS_CSG_2" ("micro strain")
— "MS_CSG_3" ("micro strain") — "MS_CSG_4" ("micro strain")
