# Preliminary investigation of key factors in pedestrian bridge health monitoring using cost-effective IoT platform

Prof. Hong Guan<sup>1</sup>, Huiyue Qiao<sup>1</sup>, A/Prof. Yong Zhu<sup>1</sup>, Dr. Shoja Jamali<sup>2</sup>

<sup>1</sup> School of Engineering and Building Environment, Griffith University

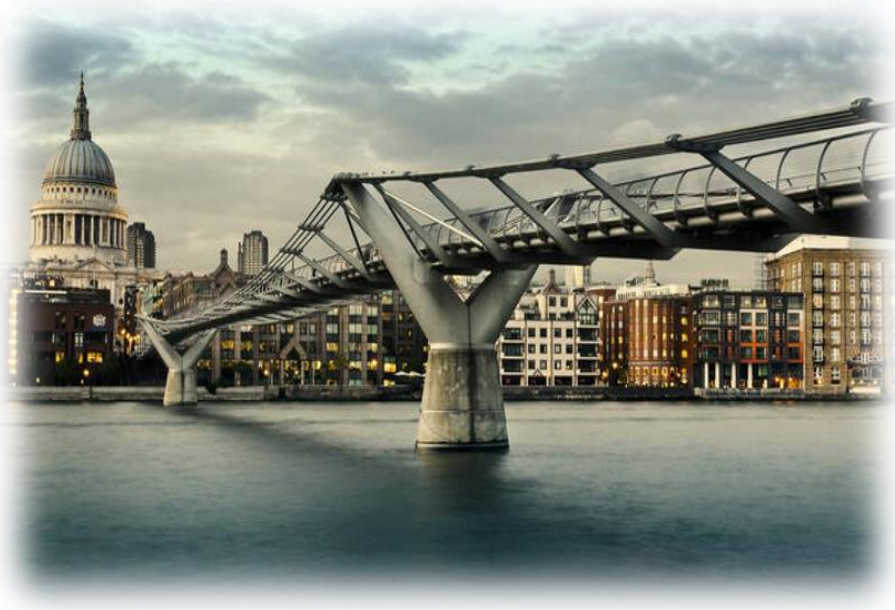
## Millennium Bridge, London "Wobbly Bridge"

- Unexpected lateral vibrational mode due to resonant structural response
- Energy exerted on the bridge from unsteady pedestrians to keep balance → more wobbly bridge
- Synchronous lateral excitation

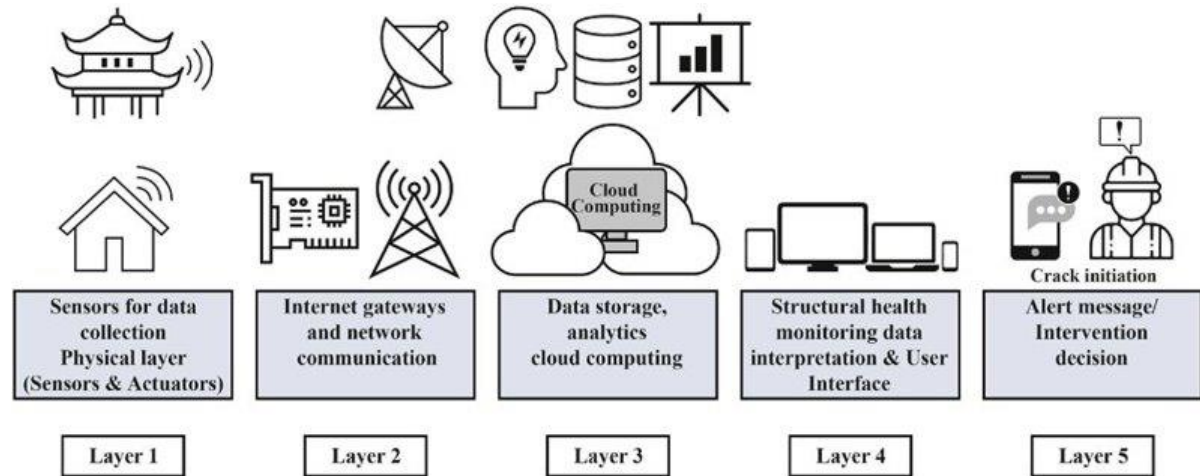
## IoT architecture for SHM applications

- Real-time test data
- Cloud-based data storage systems
- Remote data access
- Cohesive device connectivity
- Improve efficiency of existing SHM systems

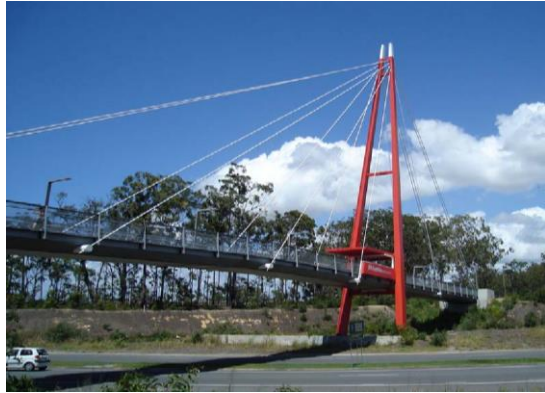
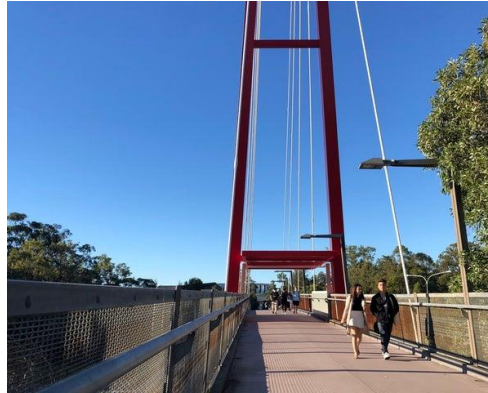
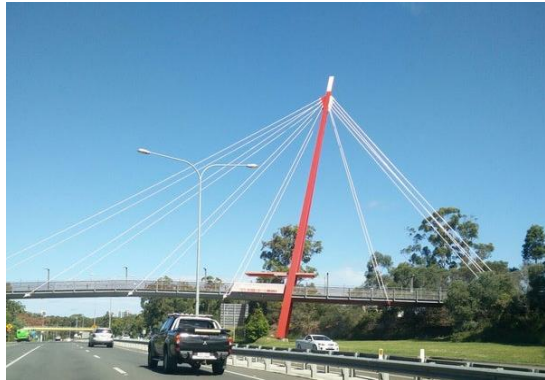
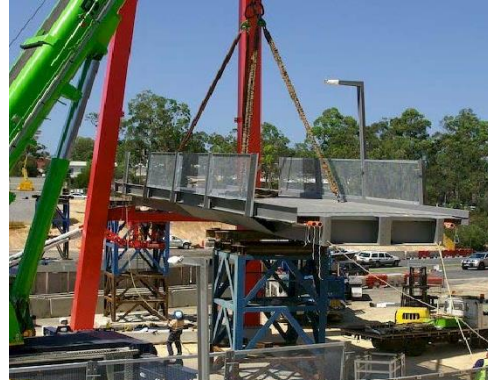
# Case study - GU cable-stayed footbridge

- Built in January 2007;
- Connect the northern campus with the student accommodation center and the GELI building on the southern side over Smith St Motorway;
- 96m long span (63m main + 33m back span), 4m wide deck (steel plate box);
- Single 1:10 sloped tower, 40m high (box section), 5 sets of anchors, 60mm & 75mm VSL MT600 bars for stays;
- Back stay anchors installed on the southern abutment to control deflections of the tower.

- Noticeable vibration
- Bolt corrosion
- Partial anchor bolt missing in abutment
